Assessment of Bacterial Leakage at the Implant-Abutment Interface of Internal and External Connection Implants: An *In Vitro* Study

Abstract

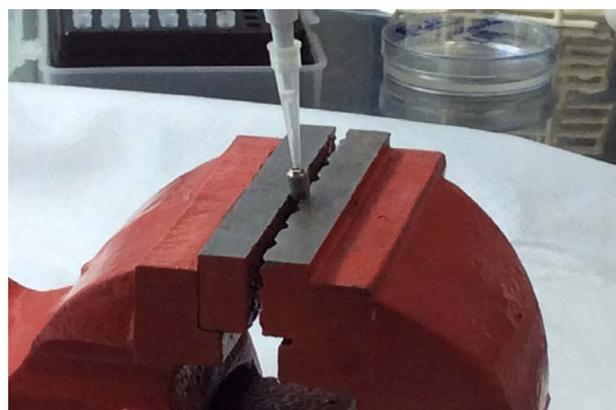
Figure 1: Solution containing *Escherichia coli* that was inoculated into the internal part of the implant.

full procedure was performed in sterile conditions, in a disinfected laminar flow cabinet. The operator was properly dressed and stayed within a safety zone provided by the flame of a Bunsen burner. The test specimens were inoculated with 0.3 µL of *E. coli* suspension (reference strain ATCC 25922), applied in the hollow part inside the implant (Figure 1), with the help of a 77FAA10 micropipette (Prolab, Santiago, Chile). The bacteria were kept frozen before use. They were then activated by inoculation in a brain-heart infusion medium (BHI, Kasvi, Italy) and maintained in an incubator at 37°C for 24 hours before the inoculation.

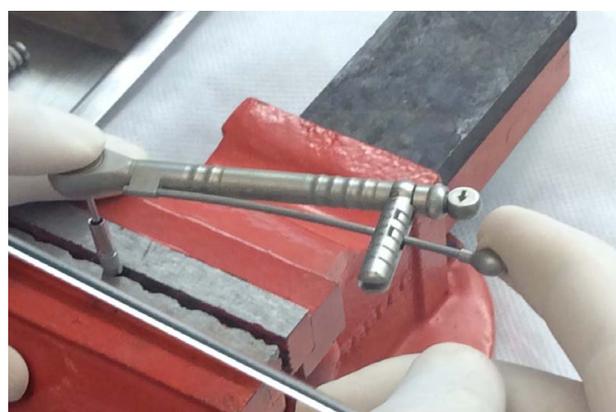
Figure 2: Application of the torque recommended by the manufacturer to the screw of the prosthetic abutment.

Immediately after inoculation, the prosthetic abutments were connected to their respective implants, and then the torque recommended by the manufacturer was applied to the abutment fixation screw (Figure 2), as described in Table 1. In order to apply the torque to the prosthetic abutment fixation screw, a torque driver from the same manufacturer was used, coupled to the respective manual torquemeter.

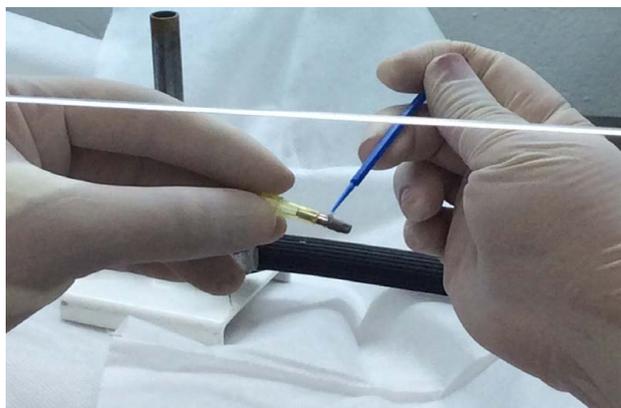
Figure 3: Microbrush dampened in saline solution spread on the implant platform in order to identify potential accidental contamination.

After applying the torque, a sterile microbrush (KG Sorensen, Cotia, SP, Brazil) dipped in saline solution was used on the implant platform in order to test the possibility of contamination during inoculation or leakage of the suspension when applying the torque to the abutment (Figure 3). A sterile plastic bit was then mounted at the edge of the prosthetic abutments to prevent them from falling into the test tubes. The test specimens and microbrushes were placed in sterile test tubes containing BHI culture medium, covering approximately 1 mm above the I-A surface (Figure 4).

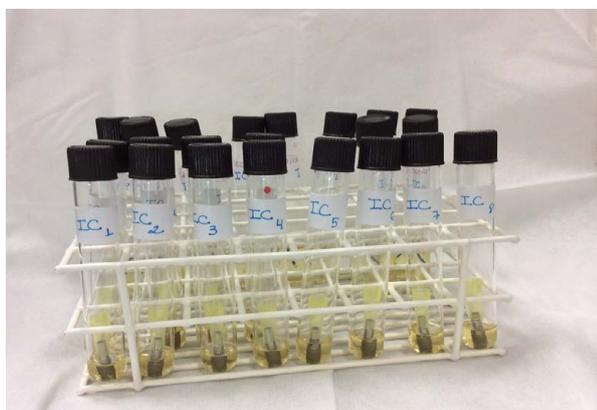
Figure 4: Implants immersed in the culture medium (BHI).

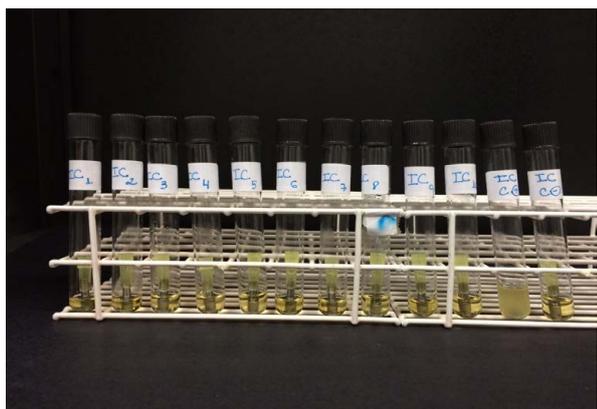
Figure 5: Group 1 samples after 14 days of incubation, showing turbidity only in the positive control samples.

The test tubes containing the inoculated test specimens and the culture medium, as well as microbrushes and positive and negative controls were incubated in a biological incubator (model Q-316M2 - Quimis Aparelhos Científicos Ltd., Diadema, SP) at 37°C. They were checked for bacteria in the culture medium after 24, 48, and 72 hours and at days 5, 7, and 14 after the inoculation by determining the turbidity of the culture medium (positive or negative) (Figure 5).

No sample in Group 1 showed bacterial leakage or microbrush contamination during the 14 days of observation. In Group 2, one sample (B-9) showed bacterial leakage after 24 hours. Subsequently, none of the other samples showed leakage. The microbrush used for sample B-6 in Group 2 tested positive for contamination in the first 24 hours, but the implant did not show evidence of bacterial leakage until the end of the observation period.
