Journal of Biodiversity Management & Forestry

Tensile Strength of Moso Bamboo Rhizome Affects Slope Stability

Abstract

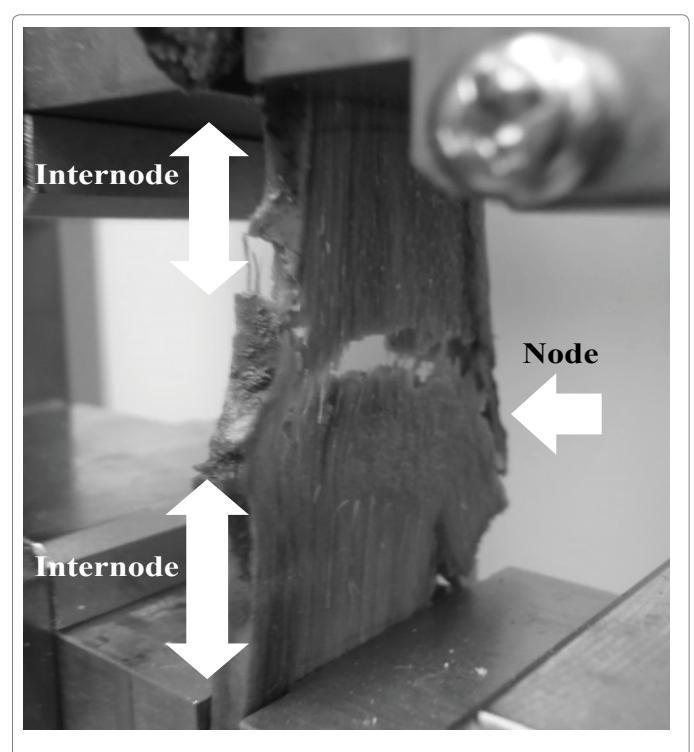
Figure 1: Tension test upon atest piece.

Test pieces consisted of parallelepiped sections that passed through the rhizome's center. These pieces were 3 mm thick and 40~80 mm in length and comprised either a node or an internode in the tension test section (Node or Internode piece, respectively). The 23 Node and 22 Internode pieces tested (45 in total). Eight of the 23 Node pieces, had a bud, and pith appeared in the surface of five Node pieces. Seven of the 22 Internode pieces, had a pith hole in cross sections. A universal testing machine (manufactured by Shimadzu Co, Kyoto, Japan.) was used, setting displacement rate at 10 mm/min and tension test section at 30~70 mm (Figure 1).

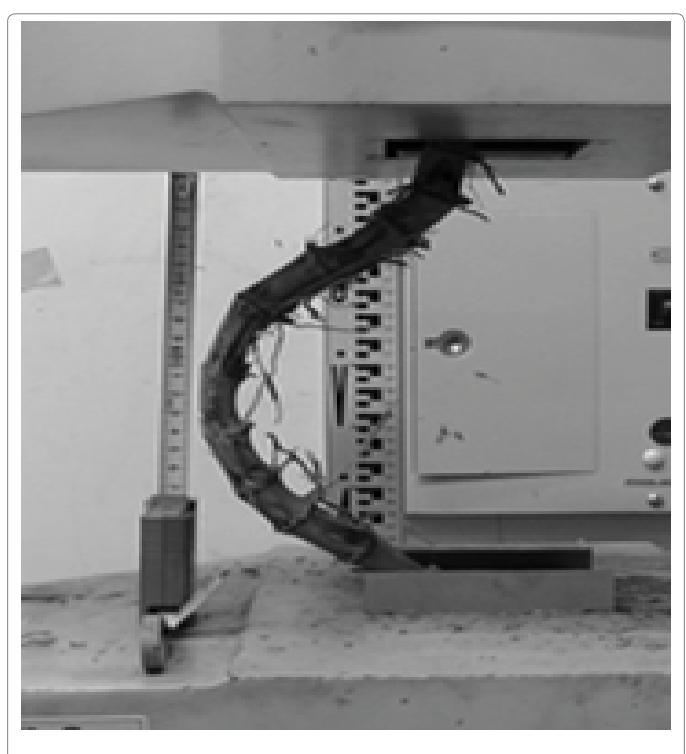
Figure 2: Tension test using test specimen.

Test specimens, presented some nodes and bending when rhizomes were set for the tension test. So the test specimens were not exerted only tension, but also flexure and compress in part (Figure 2). Test specimens were processed immediately after collection, to present the same moisture status as living rhizomes. Table 1 displays the length of tension test sections and the area of broken sections, pith holes and effective area deduced pith hole area from broken section area. A universal testing machine (Shimadzu Co, Kyoto, Japan; UH-500kN) was used, setting the displacement rate at 3 mm/min. Images were processed in ImageJ software [7].

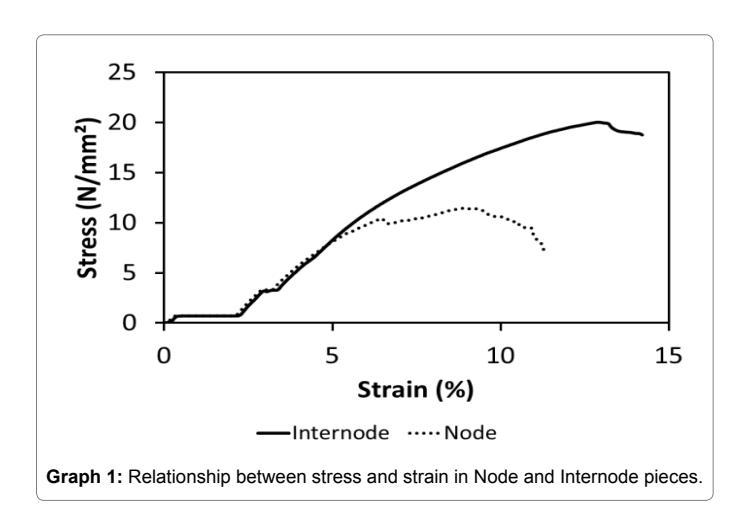
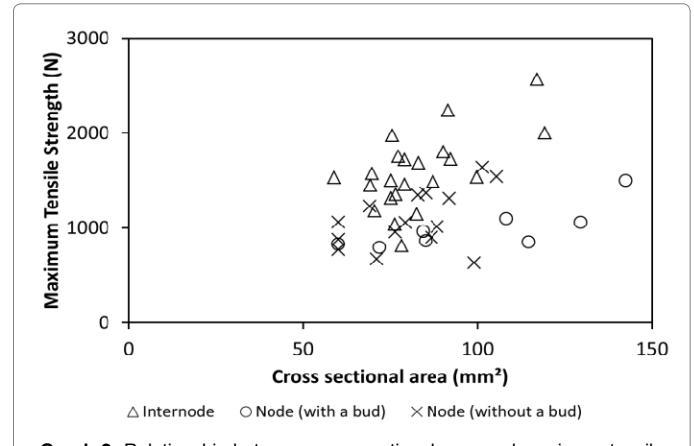
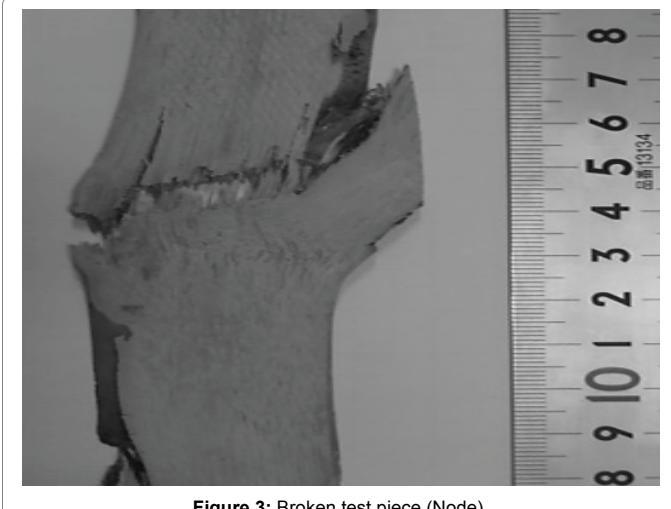
Figure 3: Broken test piece (Node).

The strain of test pieces increased by elastic deformation with increasing tension until the point at which, both stress and strain of test pieces increased by plastic deformation. When tensile strength reached its maximum, test pieces broke with stress drop (Graph 1). According to the tension test results, the maximum tensile strength for broken sectional area was weaker in Node than in Internode pieces (Graph 2). In about 70% of the Node pieces, breakage derived from a bud

nearby the node, as shown in Figure 3. In the remaining Node pieces and in Internode pieces, breakage occurred perpendicular to direction (Figure 4). Most Node pieces and Internode pieces with a pith hole, broke along the pith hole (Figure 5). Breakage at the maximum tensile point happened when epidermal structures were fractured. Structure observation revealed the existence of intermittent fibrous tissue in the node (Figure 6), and differences in the density and direction of fibrous tissue at the base of the bud (Figures 6 and 7). Thus, the decrease of tensile strength close to the node seems to be affected by the fiber discontinuity at the nearby bud.
