## Future Maintenance Effects on Life Cycle of Large Above Storage Tanks and Improvements

### Abstract

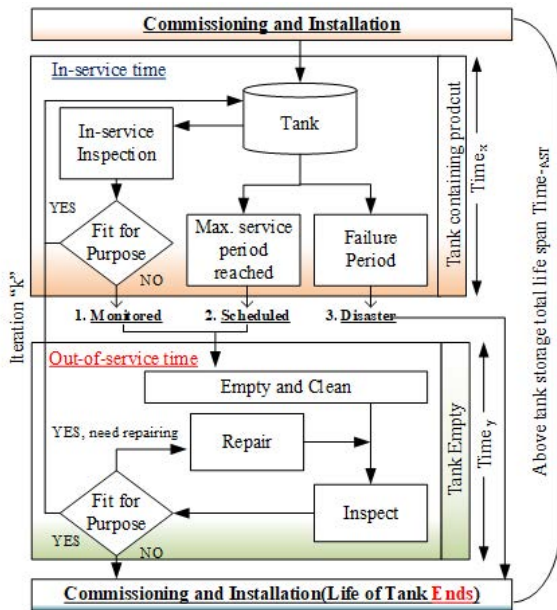
During the in-service period, there are different technologies available that are continuously monitored. Monitoring information helps decide whether to either extend the in-service time or further investigate by switching to the out-of-service period (Figure 1) [3].

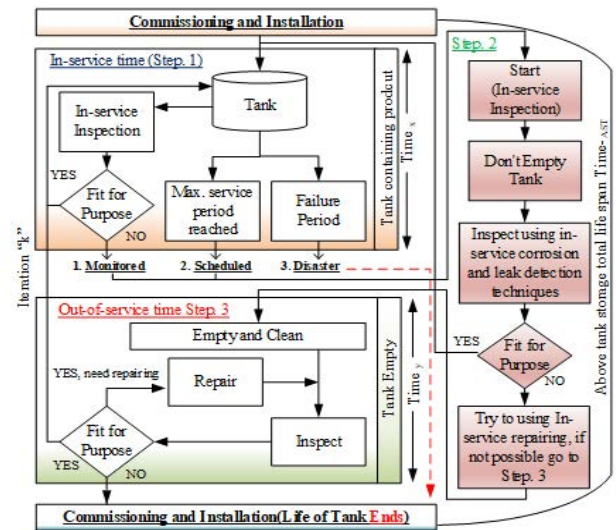
Figure 2: This diagram is suggesting optimization in output of the AST life cycle. Increasing in-service inspection time  $T-x$  and decreasing out-of-service inspection time  $T-out$ , optimization from the AST can be achieved. Life time of the AST is represented by  $T-AST$ , which is equal to  $T-x$ ,  $T-y$  and  $T-out$ .

- $T-x$  is an in-service period without any inspection.
- $T-y$  is in-service time with the efficient inspection.
- $T-out$  is an out-of-service maintenance period. During this time, an inspection and repair happened.

cracks) of the AST quickly and point the defected sections accurately. By using advanced in-service inspection techniques, we can point to defective sections accurately. Fig 2 suggests the solution in which we can increase the in-service time by using in-commission inspection techniques. By doing this, the possibility of the out-of-service maintenance is decreasing. One more way of reducing the out-of-service period is to improve out-of-service inspection techniques.

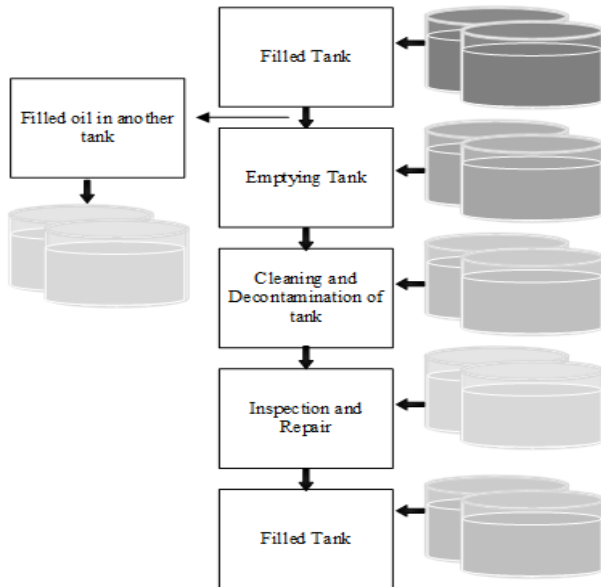
**Figure 3:** Maintenance cost increased extremely higher when cleaning process, non-productive and reduced service time taken into account. Oil transferred from affected tank to another healthy tank, which adds cost of renting or buying spare tank as well. Outline of the out-of-service for maintenance in petrochemical industry showing steps taken before inspection and repair. Reduced service time is not only the costly step, but emptying and filling oil in alternative tank is in itself very expensive.

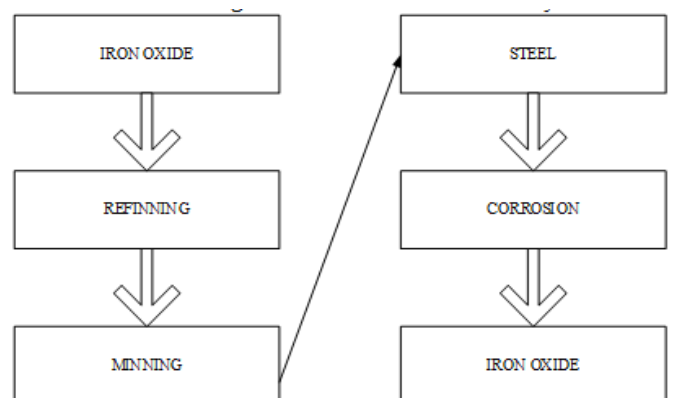
**Figure 4:** Usually ASTs storage are made of steel. Main reason behind using are, they are cheap, strong and easily store large amount of oil. Left hand side shows the refining step to make steel, right hand side is showing corrosion effects on steels. Life cycle of ASTs and corrosion are related with each other. More corrosion in tank means short life cycle.

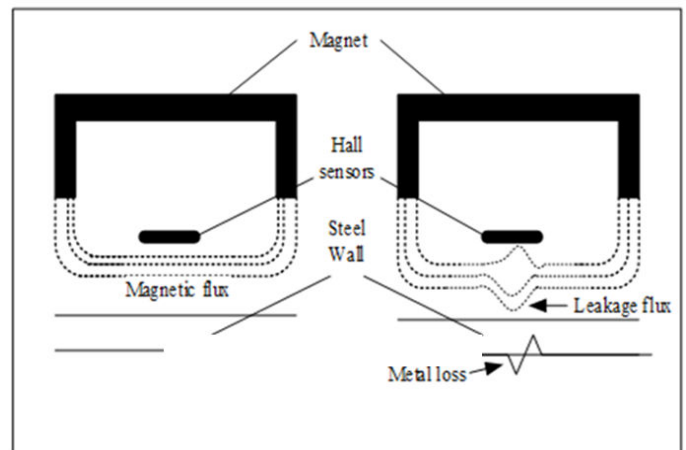
Magnetic lines of force are produced within the plate, when a magnet is close to a steel. These magnetic lines (flux) preferably like to travel within the plates than the air. A suitable powerful magnet creates saturated flux within the plate.

Coil or Hall Effect sensors can be used to detect corrosion in the tanks; the corrosion can be identified by any irregularities fluctuation in the magnetic flux. Coil sensors works on the principle of Faradays

law and the Hall Effect sensors which generate a voltage signal dependent on flux density (Principle of Lorentz force) (Figure 5).

**Figure 5:** The principle of the MFL using hall sensors.

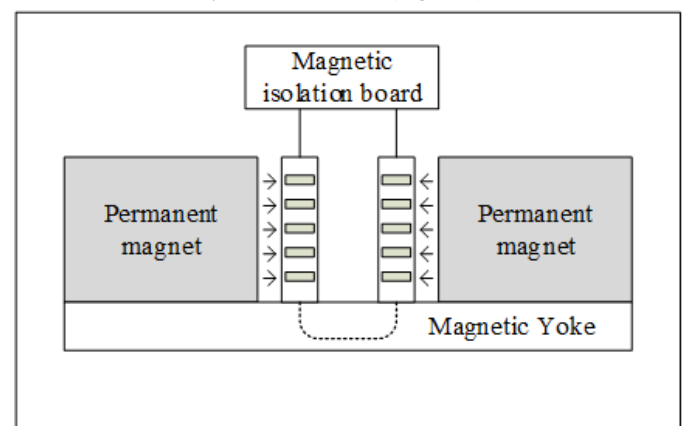
The signal to noise ratio for MFL is very low. The fast approach and sensitivity give it an edge over the tank inspection industry. Different companies are finding ways to make improvements to its efficiency for MFL. The sensitivity of the MFL depends on different factors. Air coupling magnetic field, geometry, and position of defect, anticorrosive coating, and roughen material effects sensitivity. Air coupling magnetic field between sensors is quite big. This usually affects the sensitivity of MFL and results in false alarms. False magnetic fields can be reduced by using the shielding structure. This shielding structure has the potential to decrease inspection time and increase the sensitivity of MFL devices (Figure 6) [10].

**Figure 6:** The principle of Magnetic shield structure.

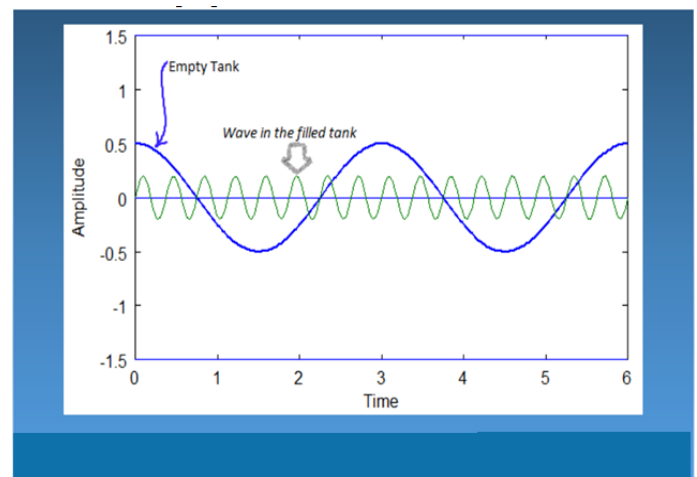
**Tomographic reconstruction:** Across all ASTs floors, the transmission and receiving of waves been carried differ in their directions. The waves' amplitude is the function of attenuation due to corrosion and scattering effects in tanks (Figure 7).

**Figure 7:** Waves transmitted across the test tank shown.

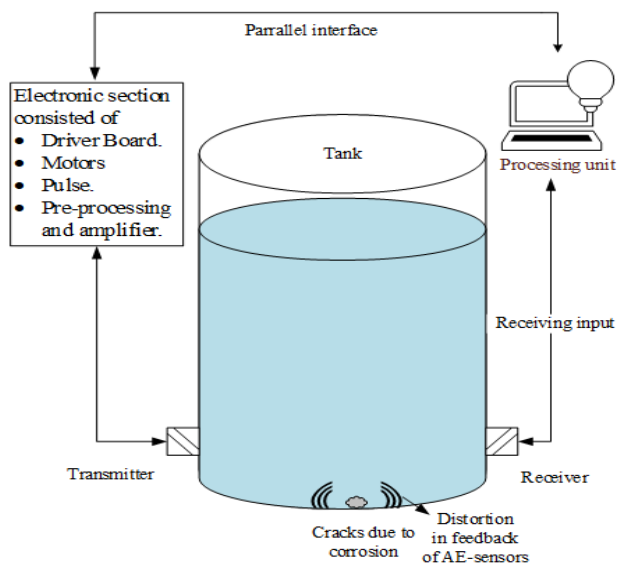
Ultrasonic guided wave tomography has been implemented on the small above-ground tank, but accuracy needs more improvement to the big tank. The experimental procedure was executed with steel plates (up to 6 mm thick) on the 100 m diameter tank and showed promising results. Things to improve in this technology are swift scanning, optimisation in resolution and signal to noise ratio (Figure 8).

Figure 8: The experimental ultrasonic tomography system.

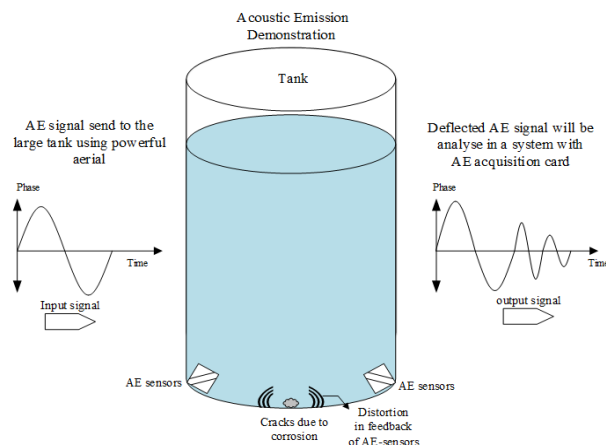
This method may be defined as a semi-in-service technique. In this method, ASTs are still undergoing off-service for a small duration. Before the tanks are tested, they need to be shut down anywhere between 6 hours to 12 hours, including all agitators, heaters and oil pipes (Figure 9).

Figure 9: Pulse of energy from the floor material can be detected by attaching sensors on the floor outside of the tank. The sensors and floor is acoustically coupled, also special setup is required to improve transmission of the AE signals.

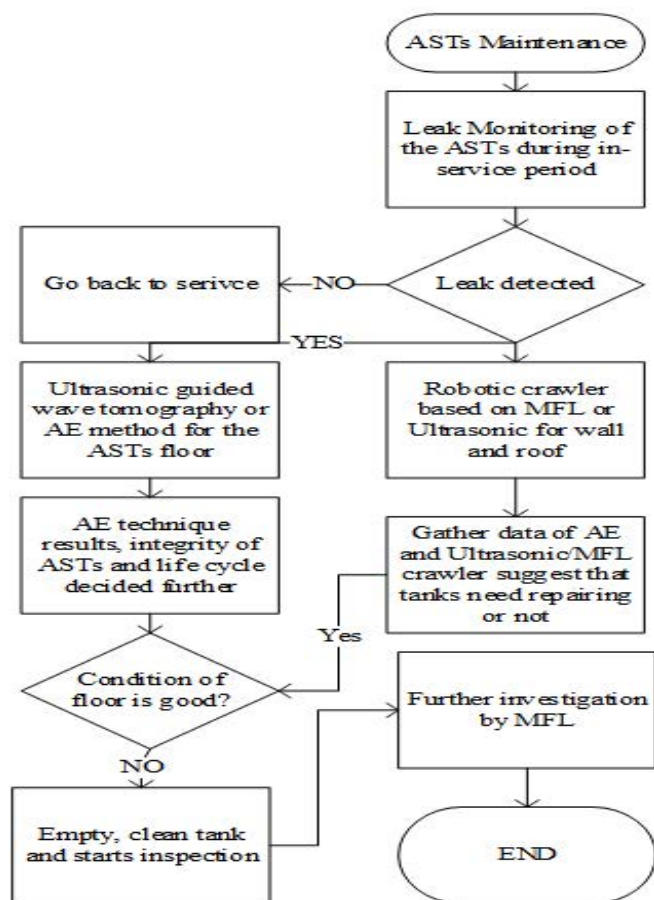
Figure 10: Flowchart of complete inspection technique for the AST.

Ultrasonic wave-guided Tomography or AE techniques can spot faults on the ASTs floor quicker both decreasing the chance of emptying, cleaning and inspecting by other non-destructive testing (NDT) sources, thereby minimizing costs. They can resolve any false results obtained from leak monitoring results. If results are not accurate, then opening of the tank is needed for further investigation, on the other hand MFL may be used for inspection of floors in tanks. In addition, automated ultrasonic or MFL robots may be adopted for wall and roof of tanks. British Sliver Wing Group has crawler devices, which can access wall and roof of ASTs.

The above flowchart concludes that combination of quickness from Ultrasonic wave guided Tomography or AE, accuracy from MFL, can provide a much better result. If AE findings are satisfactory we don't need to go any further, thus no need for any floor inspections by MFL. By following this procedure, costly maintenance and time consuming paths can also be avoided. This process can provide accurate evaluation and optimal maintenance for safety of ASTs [14].
